Architectural Variability in the Caddo Area of Eastern Texas

T. Clay Schultz

Special Publication No. 16

Friends of Northeast Texas Archaeology

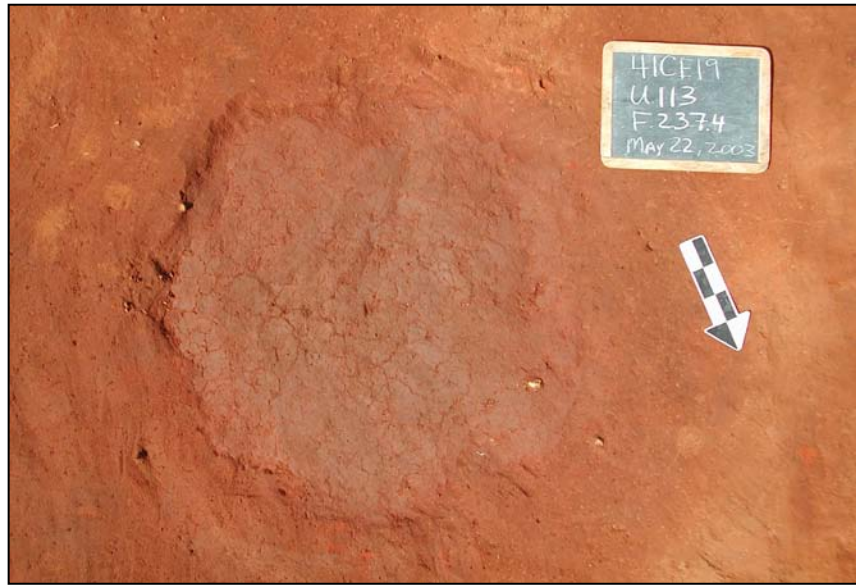
Figure 31. View of Feature 237.4.

The hearth (Feature 237.4) was initially identified as a large dark stain (Figure 31) at the plow zone/subsoil interface. The feature represents the bottom remnant of a hard-baked, heavily-fired clay hearth. The hearth had a diameter of ca. 70-75 cm. Samples for archaeomagnetic dating were collected from the edges of the feature. The northern half of the hearth was removed (Figure 32) and all fill was saved for flotation. The fill directly below the hearth was red with gray clay mottling. A single sample of charred material was collected for AMS dating from below the hearth. Previously excavated hearths from the Davis site have diameters ranging from 48 to 183 cm and depths from 3 to 45 cm bs (Newell and Krieger 1949; Spock 1977).

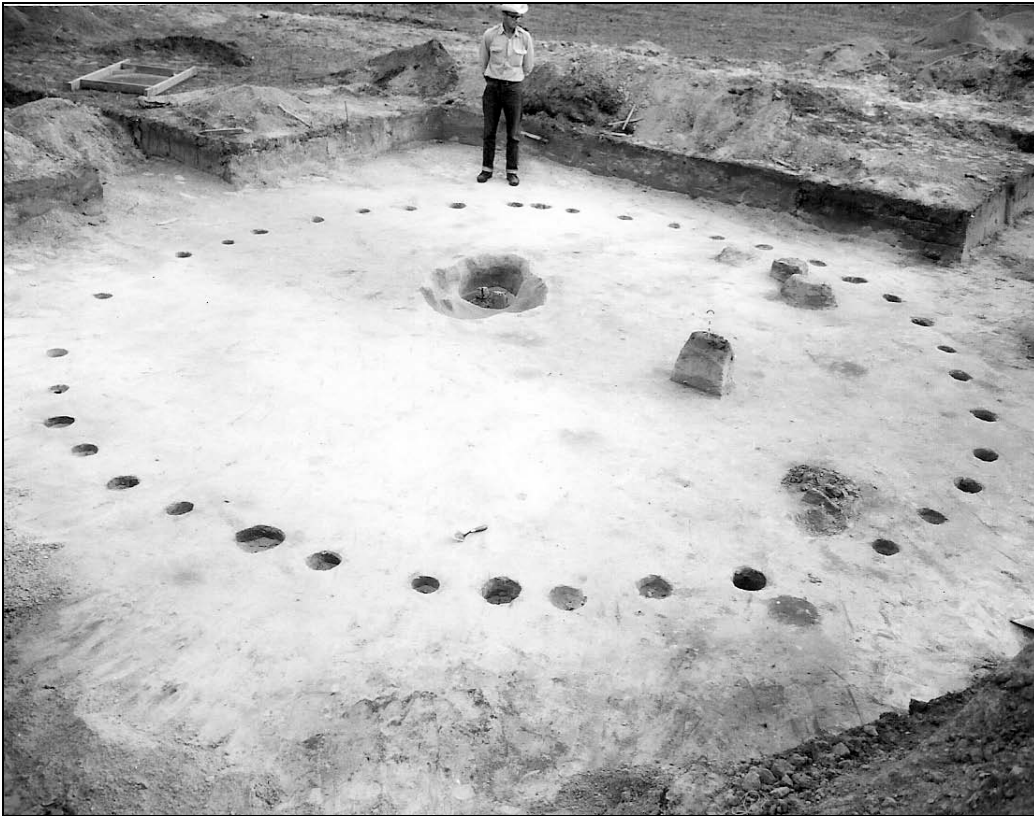
Figure 72. Structure 2 at the Walter Bell Site (Jelks 1965:314 and Figure 22).

northwest sides that measured 1.46 and 1.2 m wide, respectively. For Jelks (1965:56), it was difficult to discern the exact number of posts that made up the perimeter of the structure, but it probably had between 30 and 40 posts. Seven post holes were identified on the structure interior, but no hearth was found. The floor of the structure was likely in the midden level immediately above where the structure was first identified, “probably not far from the modern surface of the ground” (Jelks 1965:56). This explains the shallowness of the perimeter poles since none were deeper than 0.15 m below the dark midden zone (Zone 2) that extended to about 0.15-0.30 m bs (Jelks 1965).
